# Building Assessment and Condition Survey

Defense Mapping Agency (DMA)/Turner Barn Site  
Intersection of Springvale Road and Georgetown Pike  
Great Falls, Virginia 22066

October 1999

ET Project No.: 34738

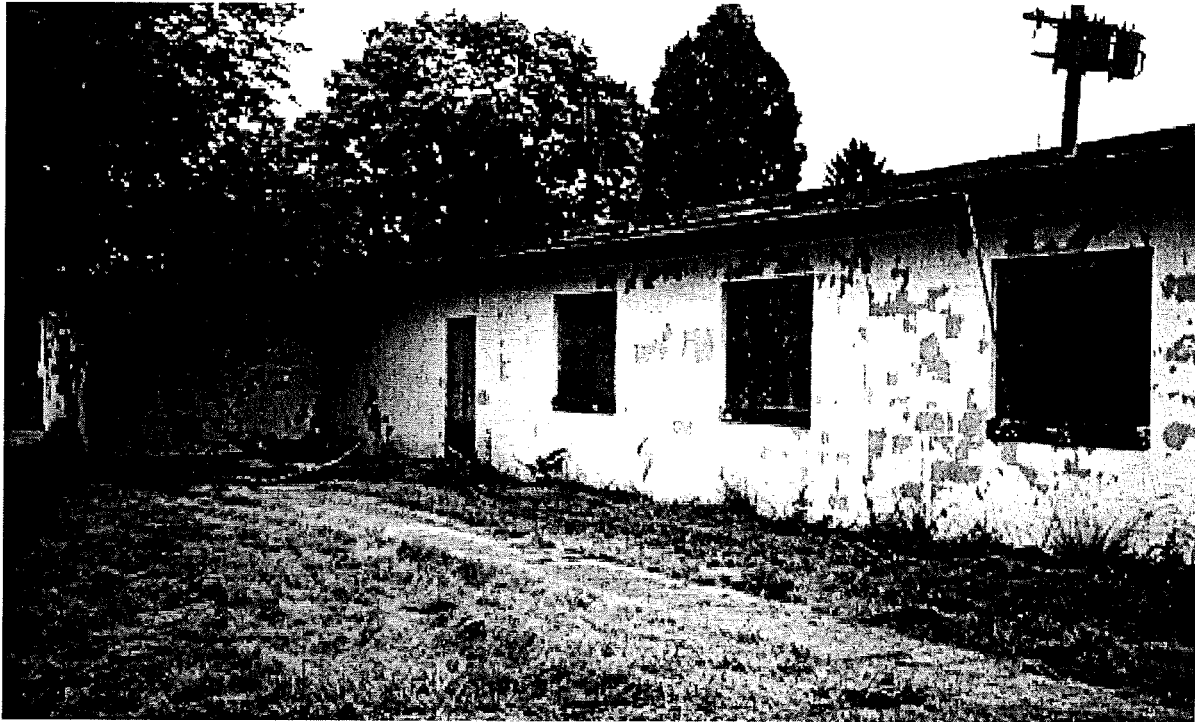
**Photo #1**

1. Buildings #1, 2, 3, 4, 8, 10, and 11 are all constructed of concrete masonry walls, exterior and some interior. The masonry walls are painted and the paint is peeling throughout all of the buildings. The masonry appears to be in generally good condition with the finish in poor condition. The window sills are painted precast concrete and appear to be in generally good condition with the paint finish in poor condition. (See Photo #1)

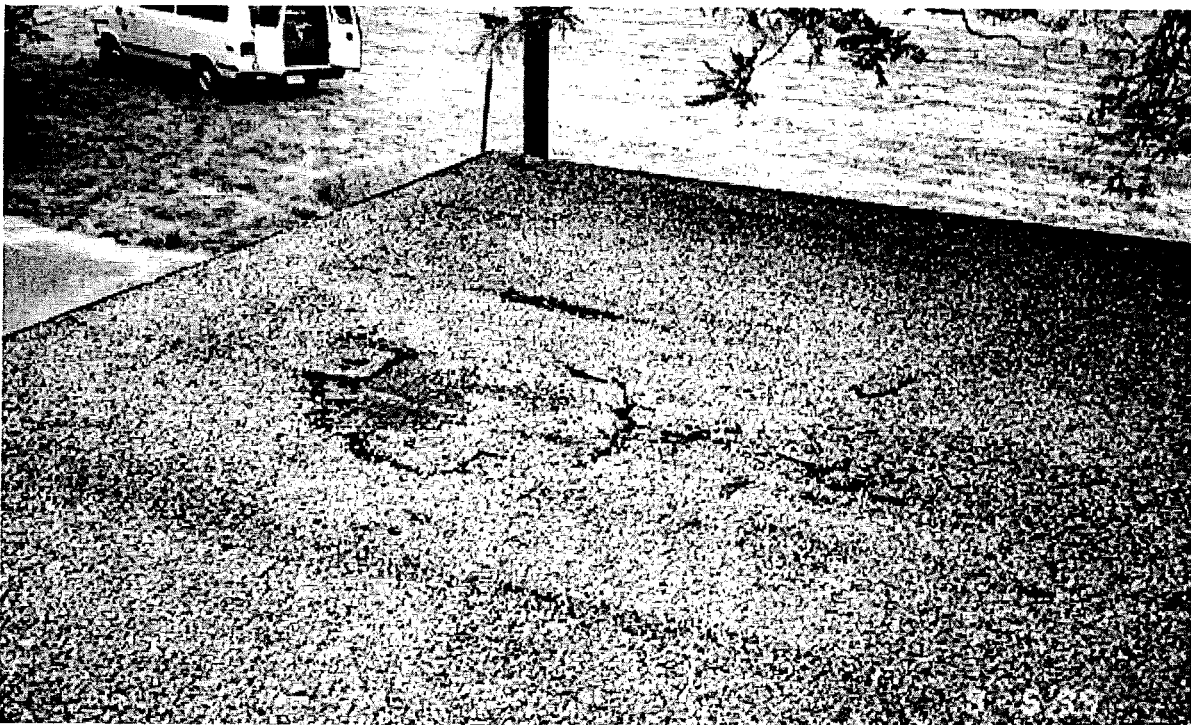
**Photo #2**

3. The roof membranes on the buildings (other than Buildings #7 and #11) are built-up tar and gravel membranes over foam insulation. Based on observations at deteriorated portions of some of the roofs, it appears there is more than one membrane on each of the buildings. There are numerous areas of blisters and deterioration to the roof membranes. Overall, the roof membranes appear to be in poor to fair condition. (See Photos #2 and #3)

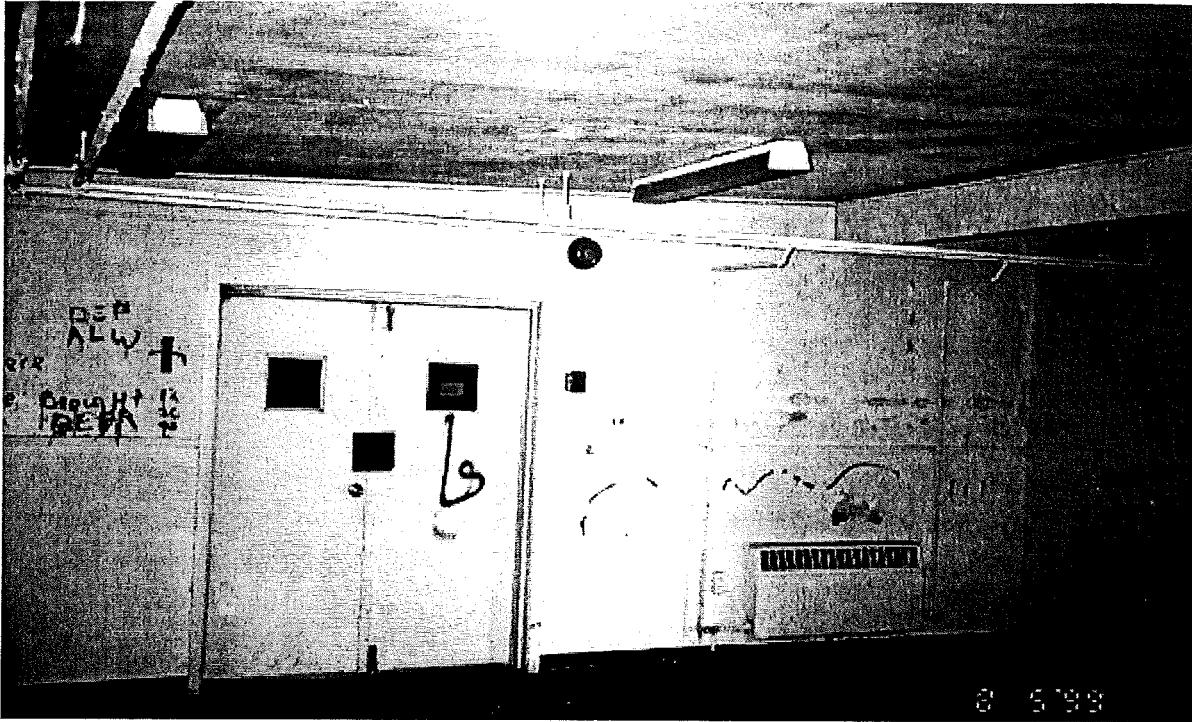
Photo #5

10. The interior finish on the exterior walls is gypsum board. There are transite panels in some of the buildings, on portions of some of the walls. The walls in Building #4 have been defaced with spray paint. The gypsum board and transite panels appear to be in generally fair to good condition, although there are numerous areas of holes in the panels. (See Photo #5)

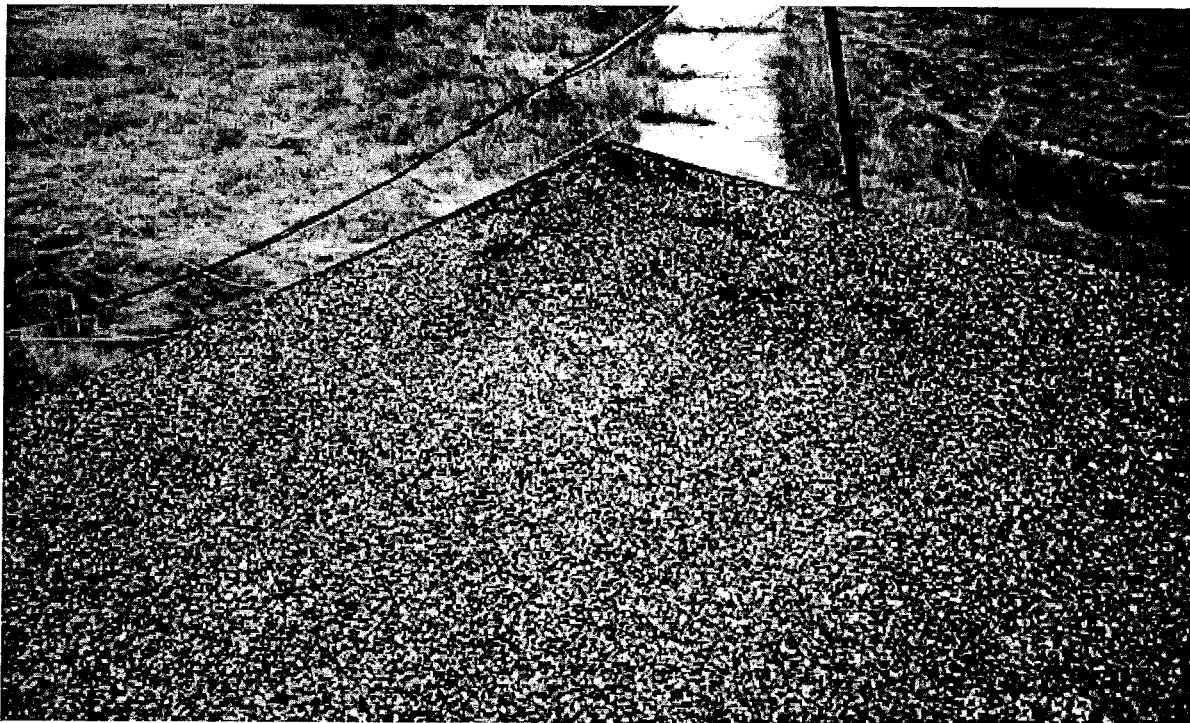
Photo #6

2. There is severe membrane deterioration in the southwest corner of the building where water appears to collect and has entered the building causing damage to the interior finishes. (See Photo #6)

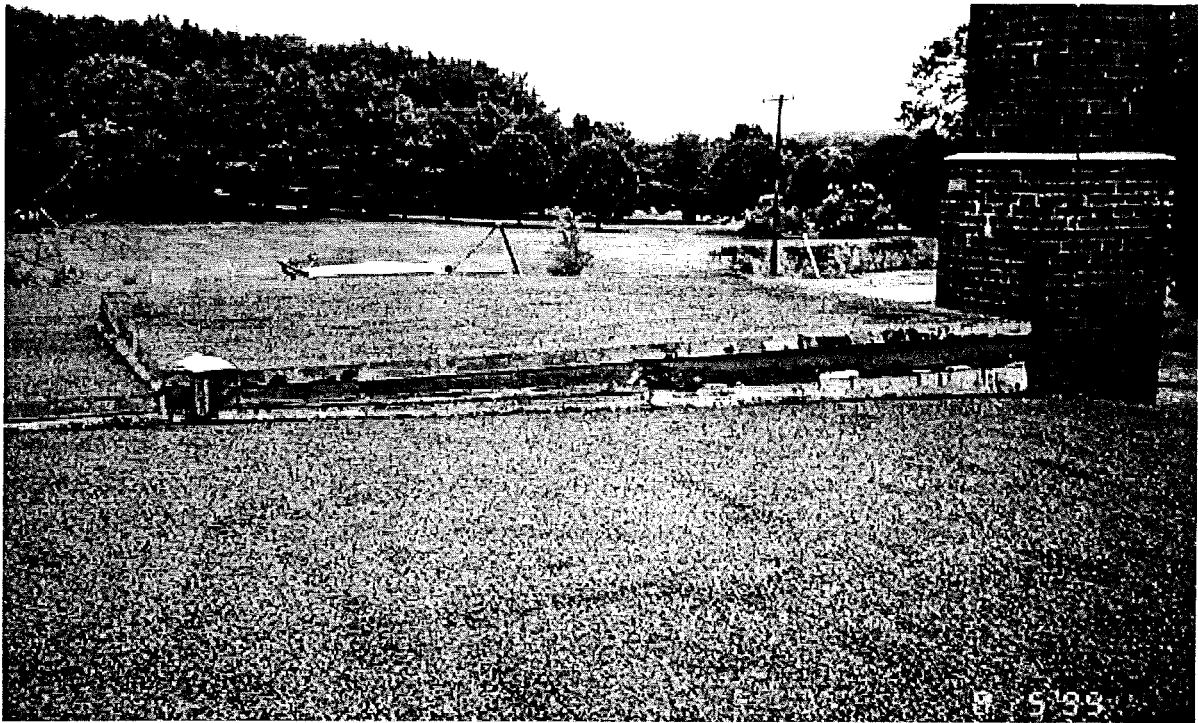
**Photo #7**

3. There are 3 distinct roof areas on the building. (See Photo #7) The trim and flashing all appear to be in poor condition. There is an opening in the membrane where the roof pitch changes from an east-west direction to north-south, in the area above the main entrance to the building.

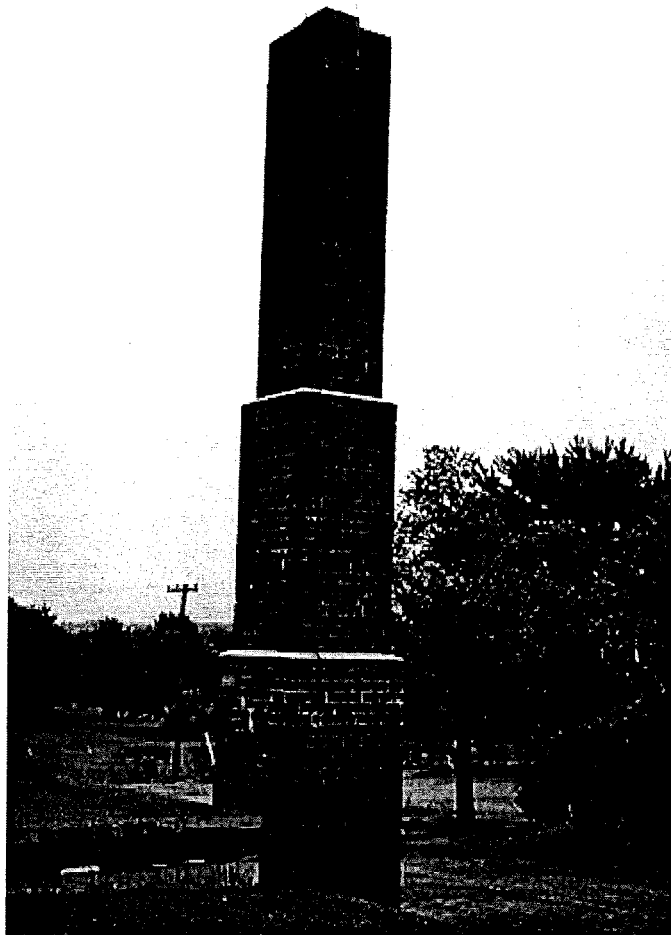
**Photo #8**

4. The wood trim on the roof overhang at the north door shows signs of deterioration and appears to be in poor condition.
5. There is a brick chimney for the boiler stack adjacent to the boiler room. The brick appears to be in generally good condition with minor areas of spalled brick. (See Photo #8)

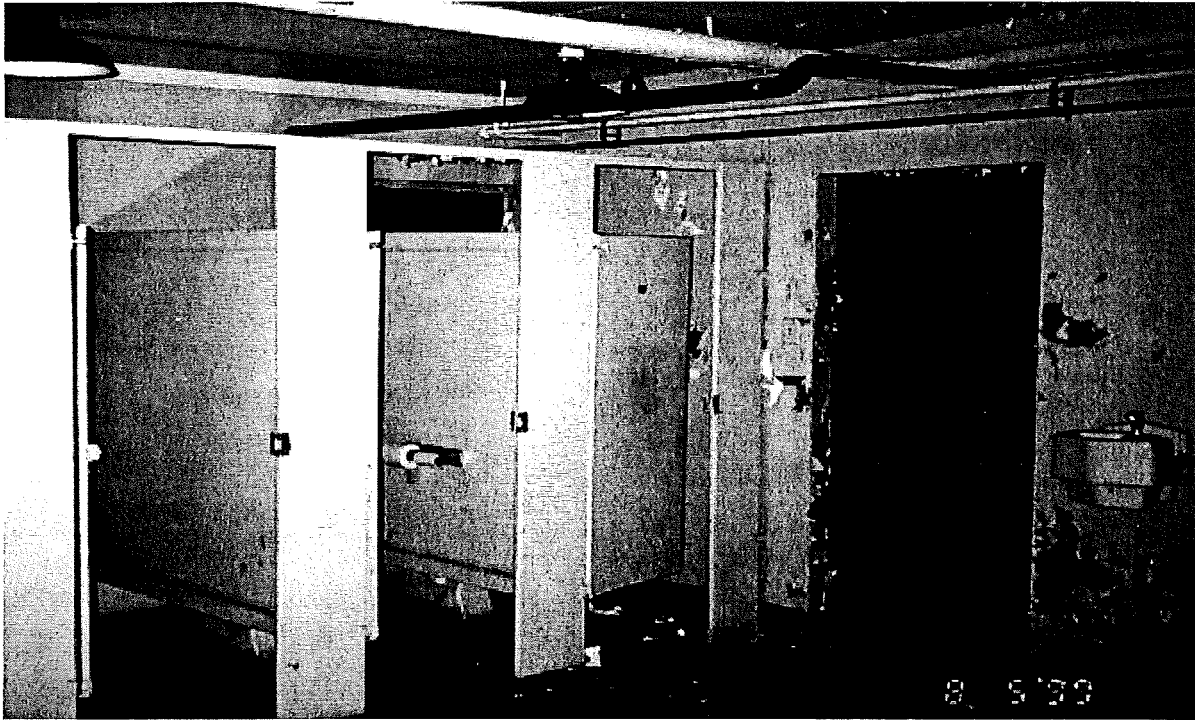
**Photo #9**

5. There are transite panels over gypsum board on the walls in the janitor's sink and shower areas that appear to be in good condition.
6. There are sheet metal toilet partitions that appear to be in good condition. (See Photo #9)
7. The plumbing fixtures include lavatories, full height urinals, floor mounted toilets, drinking fountain, and showers. The fixtures all appeared to be in generally poor to fair condition. (See Photos #10 and #11)
8. The building is heated via hot water fin tube radiation. The fin tube is fed from the boiler in Building #1.

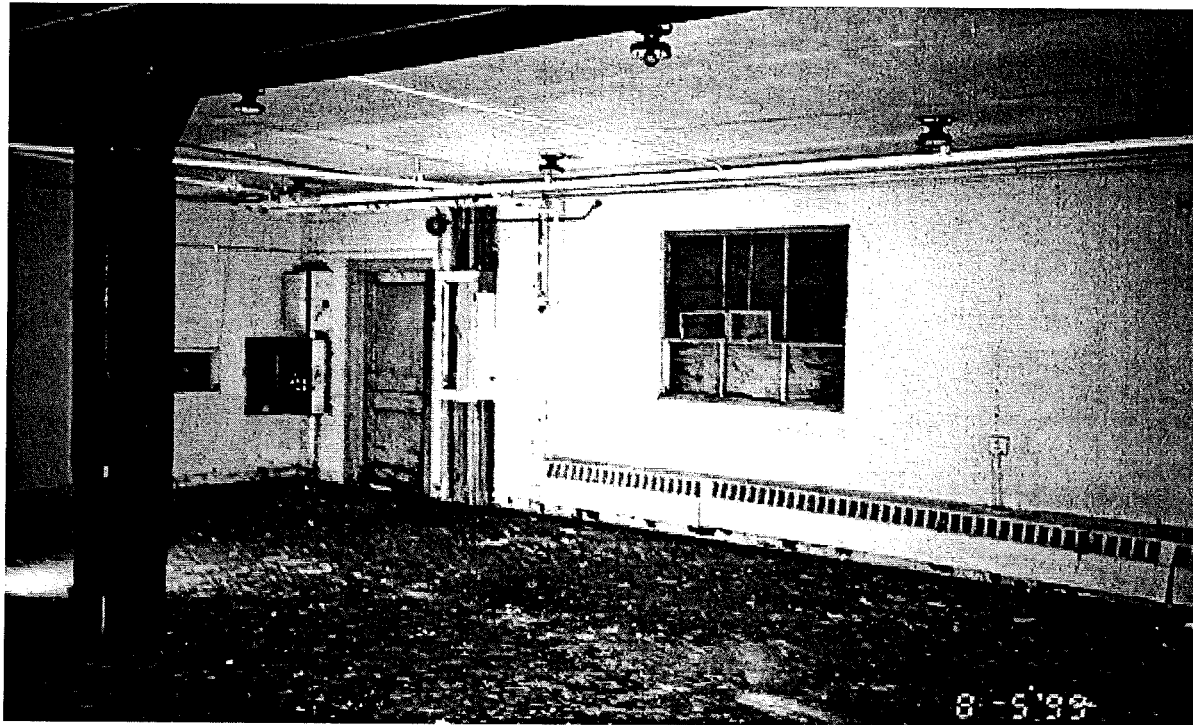
Photo #12

1. There is an area near the center of the roof that appears to have been previously repaired. The patch is not at the same level of the membrane as the rest of the roof.
2. The windows around the building are steel single pane awning windows. The windows appear to be in poor to fair condition with numerous broken glass panels. (See Photo #12)
3. There are transite ceiling panels on the east portion of the building and some areas of gypsum board patching. The ceiling on the west portion of the building is gypsum board. The ceilings appear to be in generally fair to good condition.
4. The light fixtures in the east portion of the building are fluorescent. The light fixtures in the west portion of the building are incandescent (all of the globes have been broken) and fluorescent. (See Photo #12)

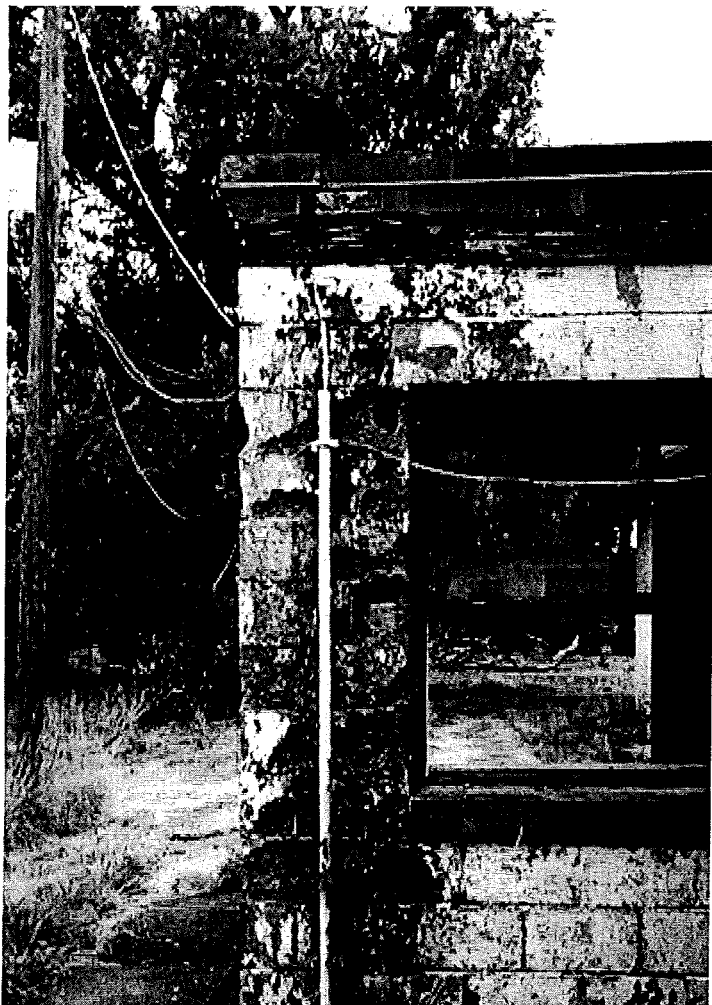
**Photo #13**

5. The northwest corner of the boiler room has experienced severe deterioration. The roof framing, trim, and masonry have been seriously damaged by water penetration into the roof and walls. When observing the roof condition it was found that there is a flat roof over the boiler room. This has most likely contributed to the deterioration of the roof and walls. (See Photos #13 and #14)

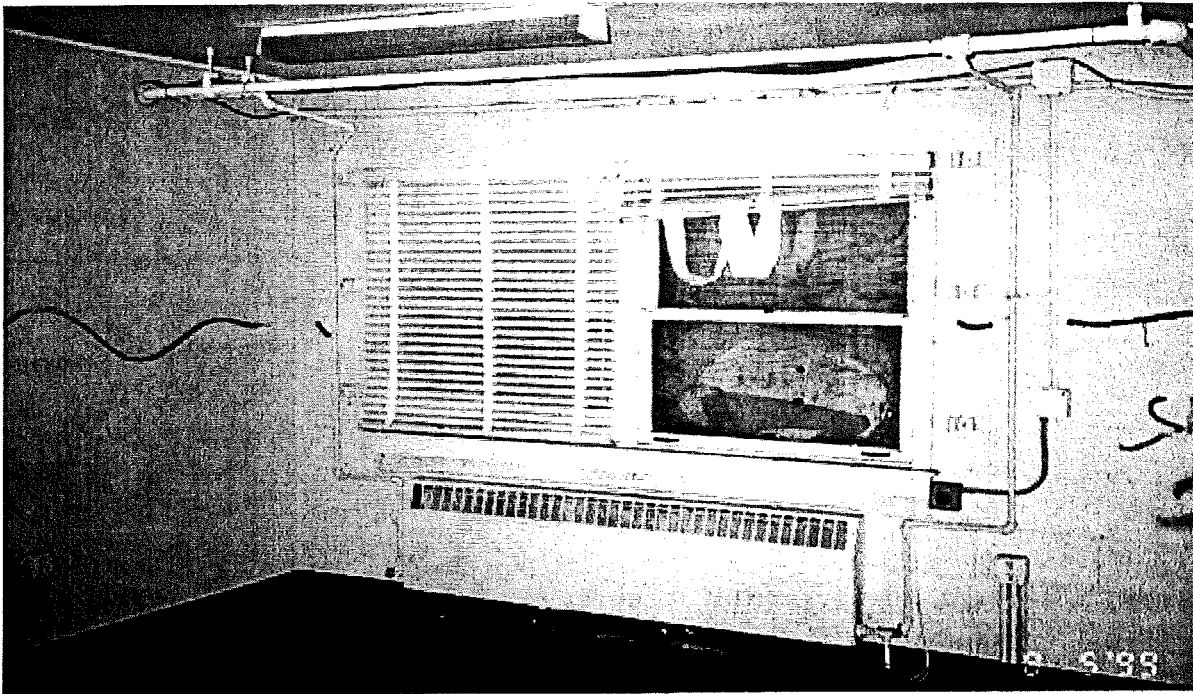
**Photo #15**

6. The walls on the interior have been defaced with spray paint and appear to be in generally fair condition. (See Photo #15)
7. The doors throughout the building are painted hollow metal doors with 10 inches by 10 inches glass panels on some of the exterior doors. The doors appear to be in generally poor to fair condition.

8. The windows around the building are wood double hung windows with insulated glass. The windows appear to be in poor to fair condition with numerous broken glass panels. (See Photo #15)

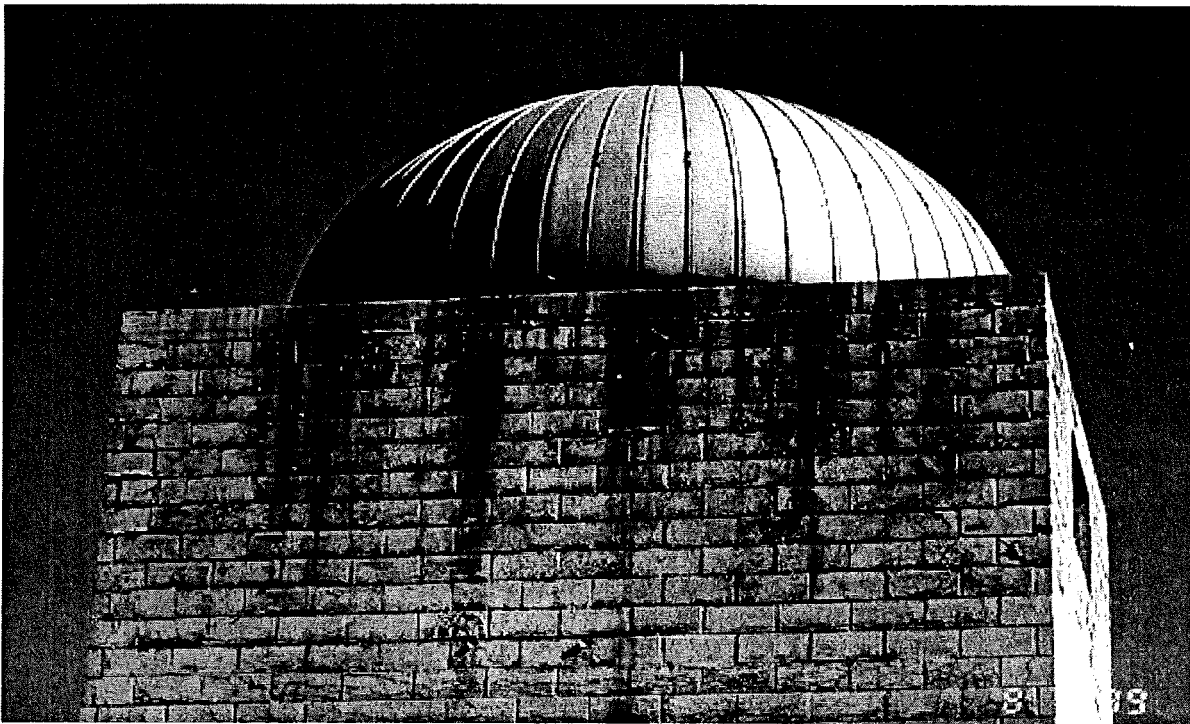
**Photo #18**

1. The walls of the building are painted concrete masonry units. On the upper eight feet of the east, south, and west exterior walls there are many areas of spalled concrete masonry units. There are minor settlement cracks on the south wall above the door and at the platform. The walls appear to be in generally fair to good condition. The paint on the exterior and interior of the walls shows signs of deterioration and water damage and is in poor condition. (See Photo #18)

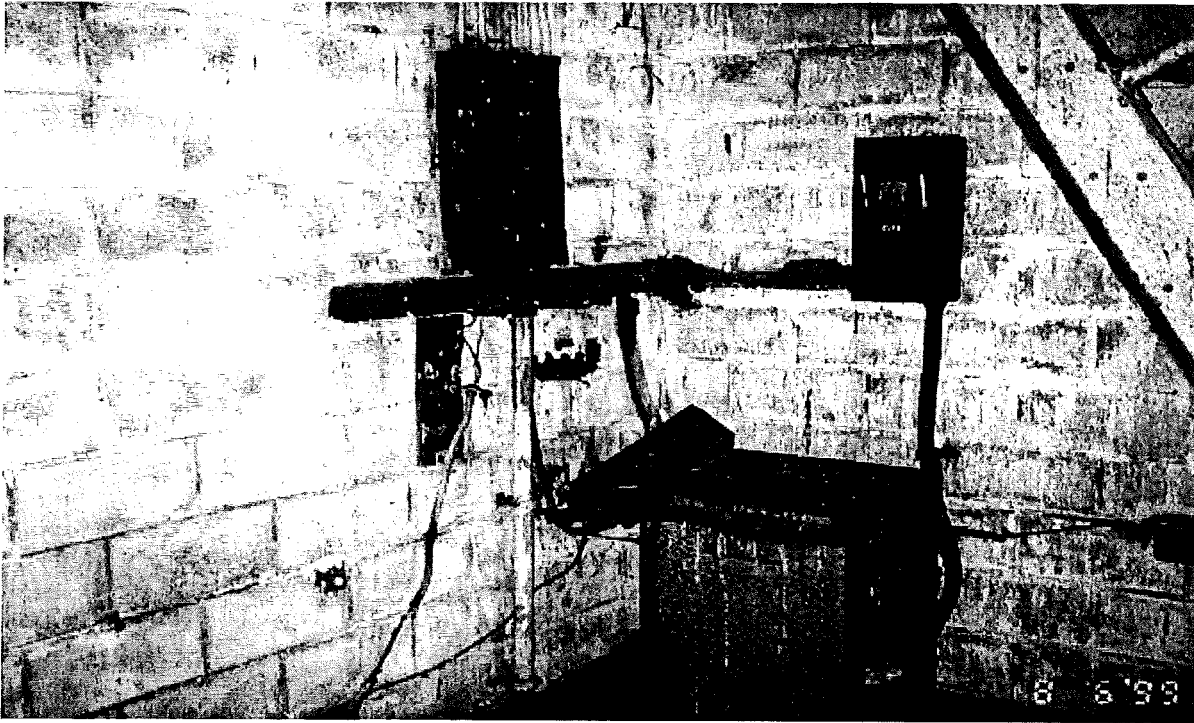
**Photo #19**

10. There is a transformer and electrical panels under the ladder that appear to be in poor condition. (See Photo #19)
8. There is a steel ladder with cage in the northwest corner for access to the walkway and platform above. The lower portion of the ladder has been cut off. The ladder and cage are rusting and appear to be in fair to poor condition. (See Photo #22)

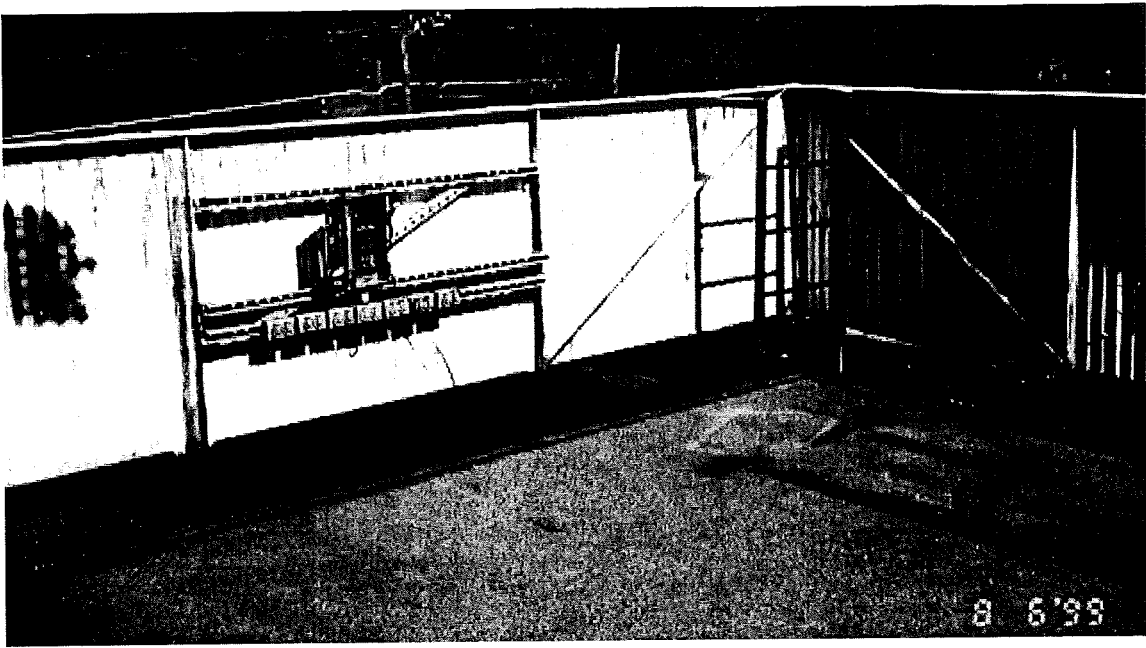
Photo #21

7. The walkway grating is rusting and appears to be in generally fair to good condition. (See Photo #21).
