# Building Assessment and Condition Survey

Defense Mapping Agency (DMA)/Turner Barn Site  
Intersection of Springvale Road and Georgetown Pike  
Great Falls, Virginia 22066

October 1999

ET Project No.: 34738

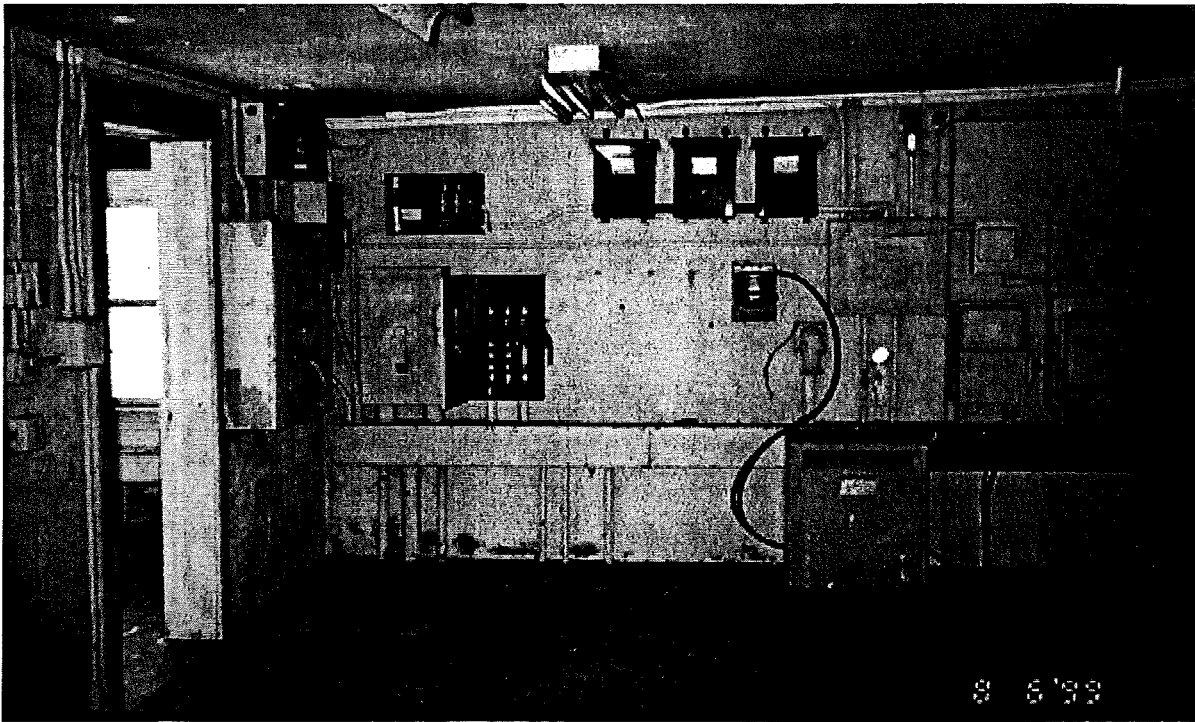
**Photo #17**

7. The floor slab is an exposed concrete slab with what appear to be isolation pads and trenches in the south portion of the building.
8. There is a transformer and high amperage electrical panels in the south portion of the building. It appears that this building once housed the facility's emergency generators. (See Photo #17)

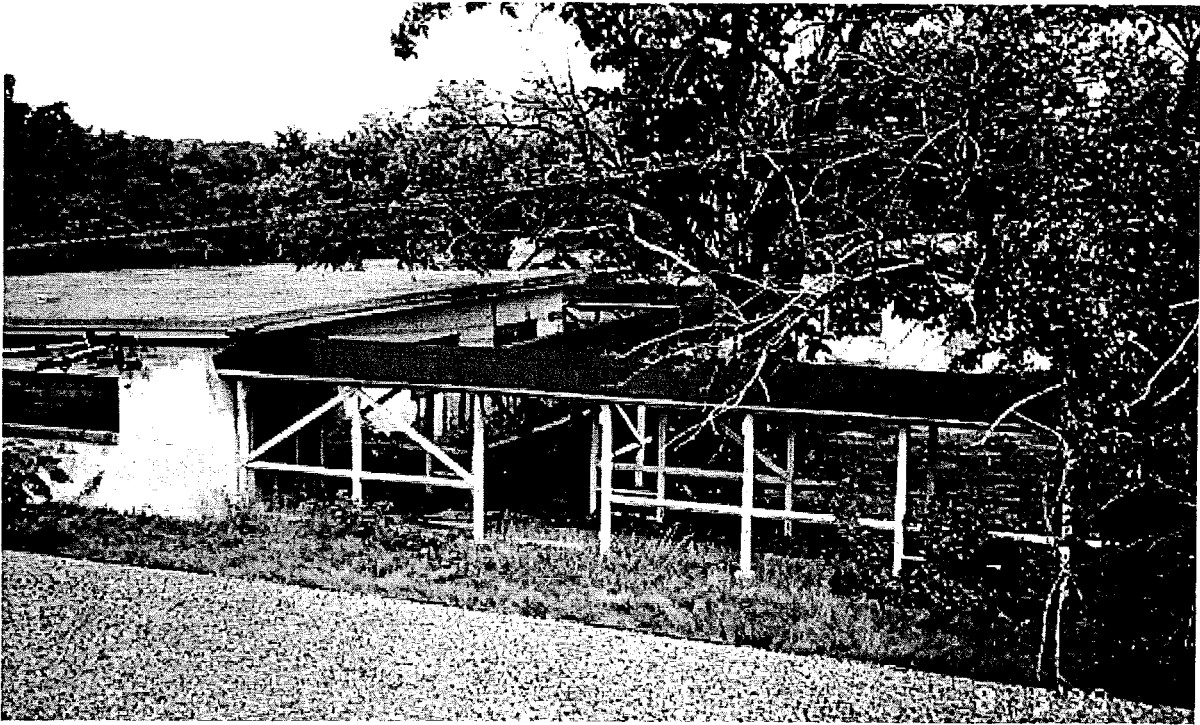
**Photo #23**

1. There is a wood framed walkway canopy connecting buildings #1 and #2. (See Photos #23 and #24)
2. The roof membrane is roll roofing with a smooth surface. The roofing appears to be in generally good condition.
3. The roof structure is painted wood and appears to be in generally fair condition with some missing and deteriorated members. The finish appears to be in fair condition.
